Manhole Inspection Summary

Manhole # S33S__058MH

Location Address: **rear 1316 race st**

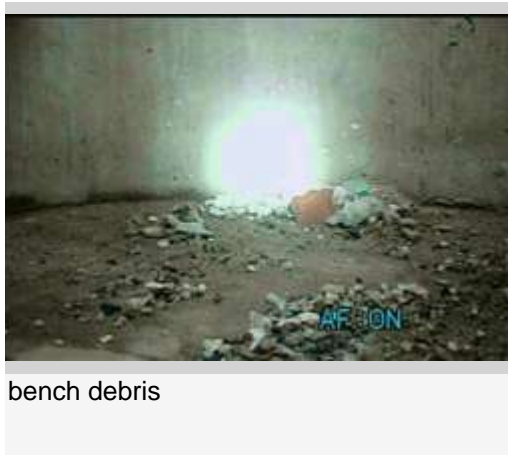
bench debris

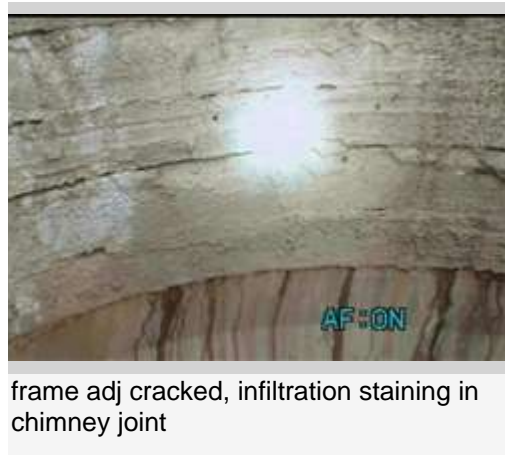
Defect 3

Condition: ☐ Sound ☒ **Cracked** ☐ Root Intrusion ☐ Loose Brick ☐ Deteriorated

Infiltration: ☐ None ☒ **Joint** ☐ Cracks ☐ Mortar ☐ Roots ☐ Wall

frame adj cracked, infiltration staining in chimney joint

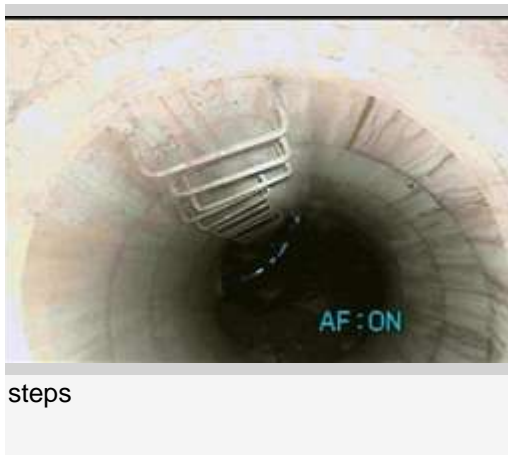
Defect 2

Count: **11** Missing: **0** ☒ **Corroded**

steps

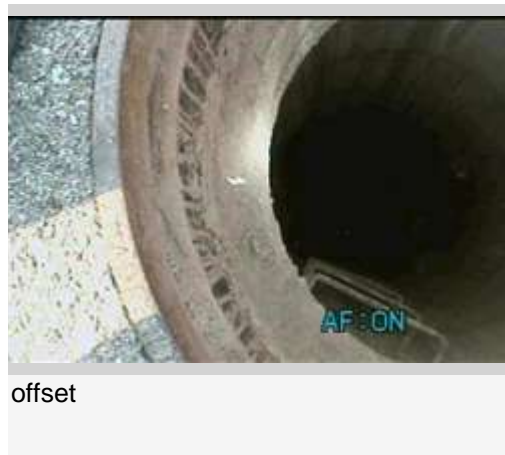
Defect 1

Offset: **2** (in.)

offset
